Inspection No: 999-062813-1

Inspection Date: June 28, 2013 @ 11:50 PM Friday

Inspection Address: MLS# SR13114838

Description	One story, Single Family Residence consists of 3 bedrooms and 2 Bathrooms. Attached 2 car garages. The living area of the house is 1349 square feet and the lot size is 7628 square feet.
Age	The house was built in 1956.
Weather	The weather was sunny (85-90 F)
Occupancy	The house occupied at the time of inspection.

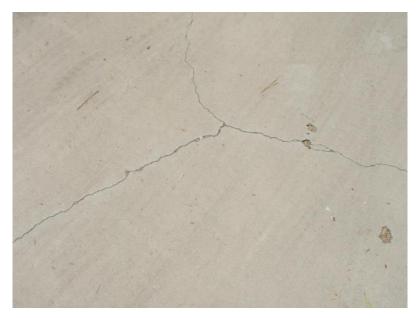
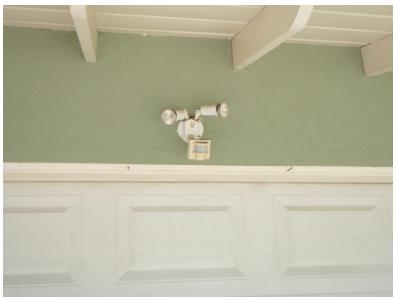
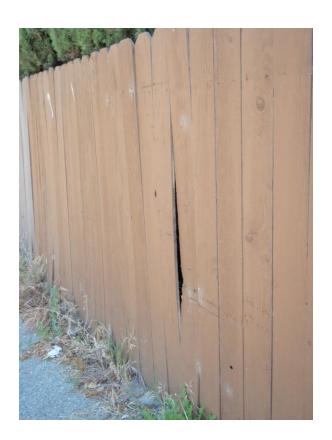
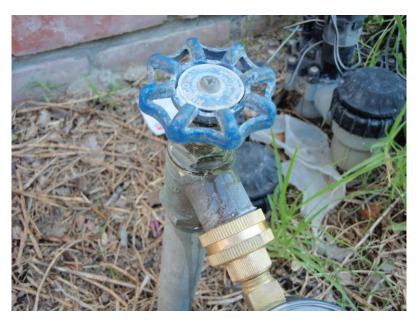
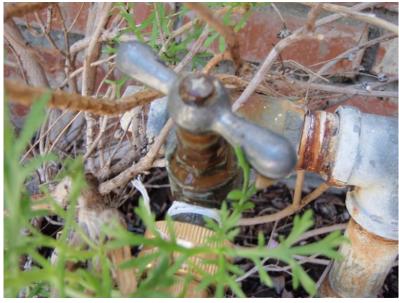
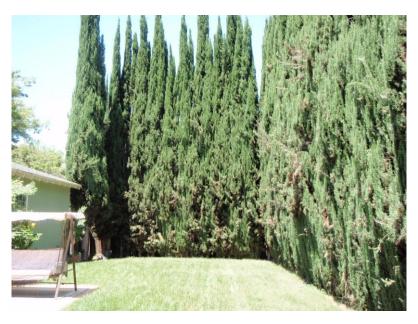
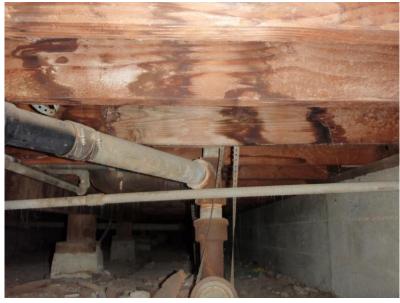
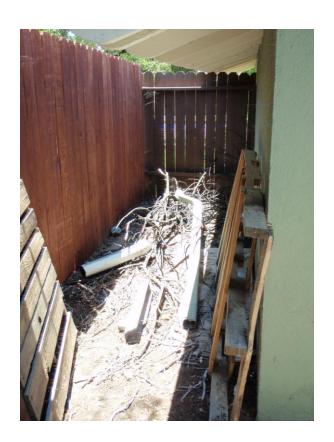
Driveway	Recommend Repair. Multiple cracks
Walkway	Serviceable
Front door	Serviceable
Screen door	N/A.
Doorbell/Chime	Serviceable
Exterior walls	Serviceable
Fence(s)/wall(s)	Recommend repair some broken panels.
Gate(s)	Serviceable.
Retaining Wall	N/A.
Trim	Serviceable
Window Frames	Serviceable.
Electrical Comments	N/A No outlet in front or back of the house. Recommend replacing 2 light fixtures
Exterior Faucets	Recommend replacing 3 exterior Faucets and changing the pipes of 2 from PVC to copper.
Landscape/Planters	Suggest trimming the cedar trees and cleaning on side the house.
Hardscape	Serviceable
Sprinkler	Recommend demonstrate the system to the buyer.
Chimney 1	Serviceable
Lot/Grade Drainage	Serviceable.
Gas meter	On the side of the house, There is seismic shut off valve, Recommend getting
	the certificate for it.
Foundation	Serviceable where visible. One-story raised foundation. Its wood structural house typical type 5. The house construction may have plumbing, gas and electrical lines running underneath the house. Since it is impossible to determine the condition of these items by our visual inspection and they specifically excluded from the scope of this inspection.

1 tuff shed located on the side of the house.

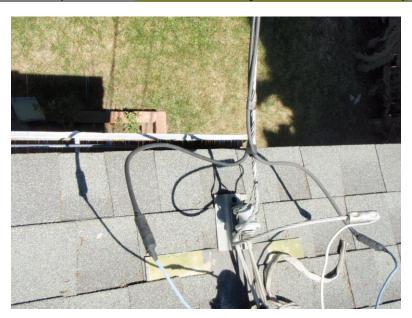
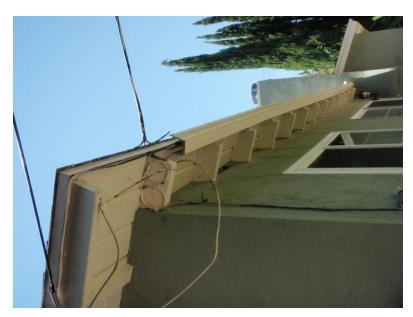
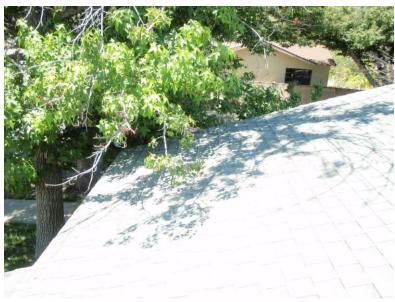
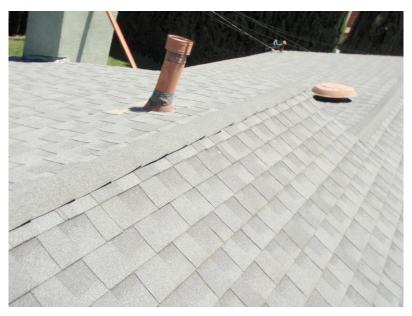
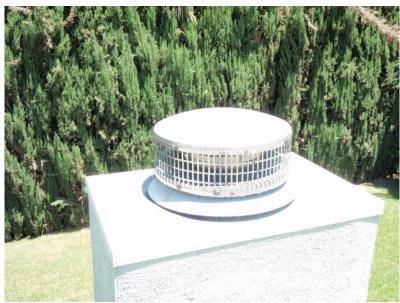
Type/Material	Shingle Roof.
Flashing	Serviceable.
Gutters/Roof Drains	Recommend Cleaning/Maintain the Gutters. Recommend replacing missing
	downspout
Roof Evaluation	Serviceable Recommend trimming the trees at least 5 feet away

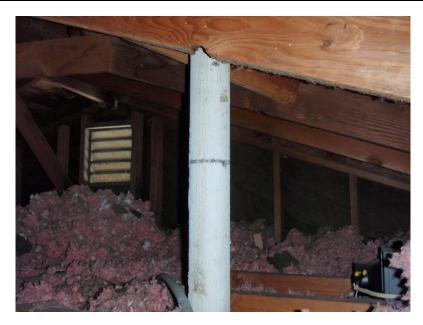
Access	From the hallway by the garage door
Framing	Serviceable.
Sheathing	Serviceable.
Insulation	Serviceable
Ventilation	Serviceable
Electrical	Serviceable
Duct	Recommend replace possible Asbestos or test it.
Pipe Vent	Recommend replace possible Asbestos or test it.

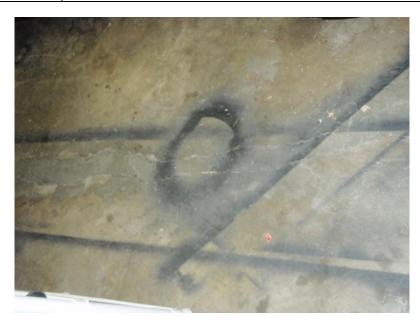
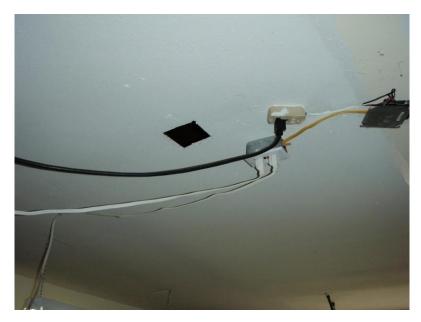
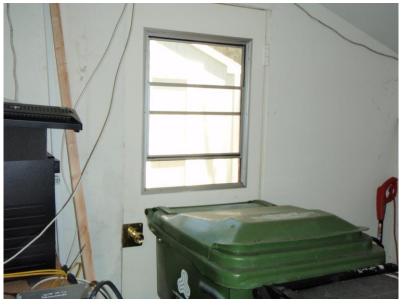
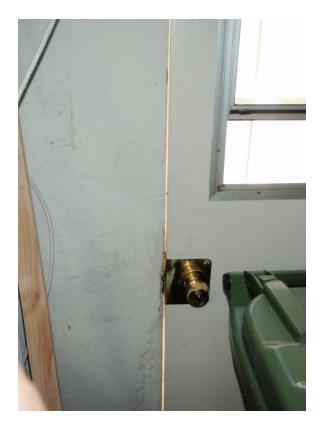
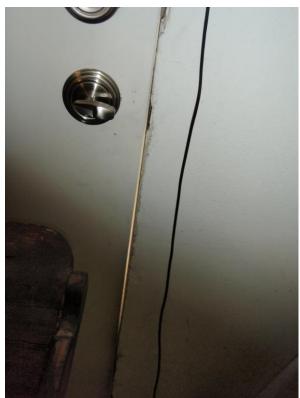
Location	Attached 2-car garage.
Exterior	Serviceable
Interior	Recommend Painting
Ceiling	Recommend repair exposed wires and patching hole
Roof	Serviceable.
Floor	Recommend power wash and repair of cracks
Garage Door	Serviceable
Garage Door Opener	Serviceable
Appliances	Water heater
Fire Door	Serviceable
Access door 1	Recommend adjusting.
Access door 2	Recommend adjusting.
Window/screen	Recommend replacing broken screen on door window
Electrical	Recommend repair outlets, ground wire seems loose. Recommend remove
	romex wiring on the ceiling and replace it with conduit.
Fire Wall	Serviceable

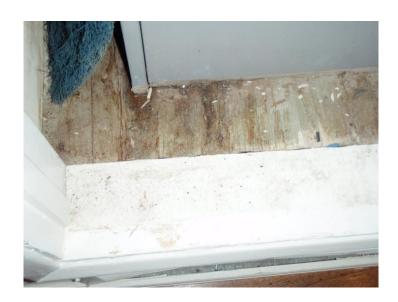
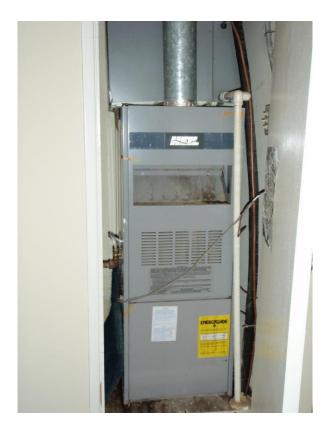
Heating	Central. Furnace located in the hallway. Possible Mold, Recommend test it or clean it up.
Heater Condition	Serviceable
Exhaust Venting	Serviceable.
Thermostat	Serviceable.
Air Condition	Serviceable

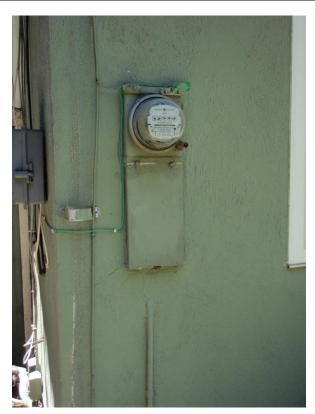
Main Box Description	Main electrical service panel located outside in the backyard, overload
	protection provided by breakers. Electrical service is 100 amps and 120 volts.
Main Box Wiring	Serviceable. Ground Fault Circuit Interrupters (GFCI) is available.
Smoke Detectors	Recommend replacing 1 smoke detector battery
Carbon Monoxide	Serviceable
detector(s)	
Outlets	Recommend repair the outlet behind the front door.

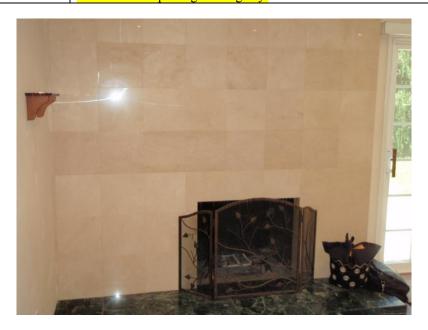
Location	In the Family room.
Condition	Recommend replacing missing key.

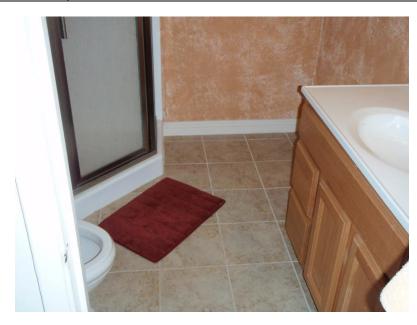
Location	Off the hallway by the Garage
Flooring	Serviceable. Tile
Walls	Serviceable. Recommend painting
Ceiling	Serviceable.
Door 1	Recommend replacing the door. Patched hole from the outside
Electrical	Serviceable.
Window(s)	Serviceable
Shower faucet	Serviceable
Shower/Enclosure	Serviceable
Shower drains	Serviceable
Sink	Serviceable.
Sink Faucet(s)	Serviceable.
Sink Drain(s)	Recommend repairing the leak
Toilet	Serviceable.
Counter(s)/Cabinet(s)	Serviceable.
Heating	N/A
Air Condition	N/A
Exhaust Fan	Serviceable.
