INTERLINK INSPECTON, INC.

Inspection No: **999-072716-1**
Inspection Date: July 27, 2016 @ 10:00 AM Wednesday
Client Name:
Inspection Address: MLS# IG16082935
APN# 290650015

Interlink Inspection, Inc performed a general home inspection of the referenced property on July 27, 2016. Enclosed is our report of the inspection findings.

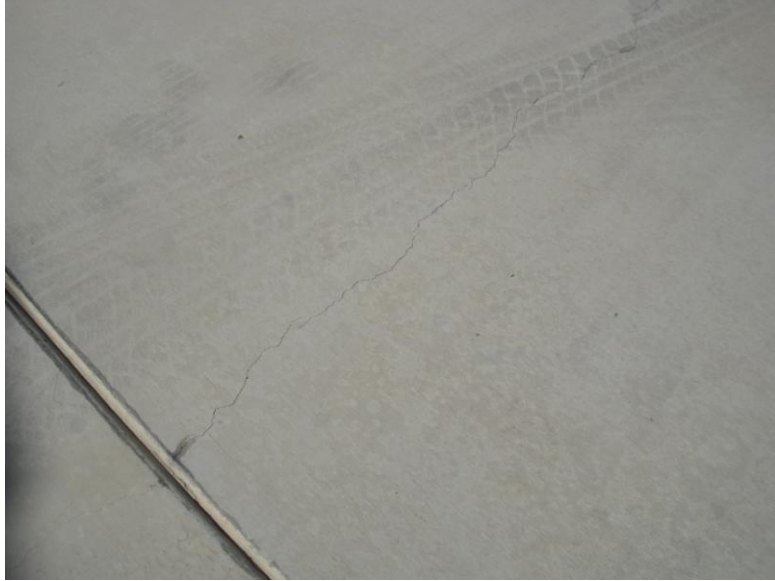
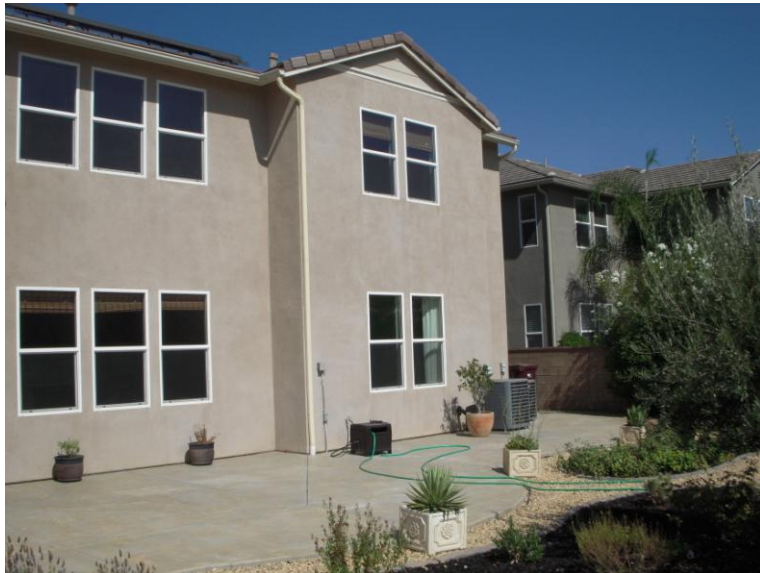
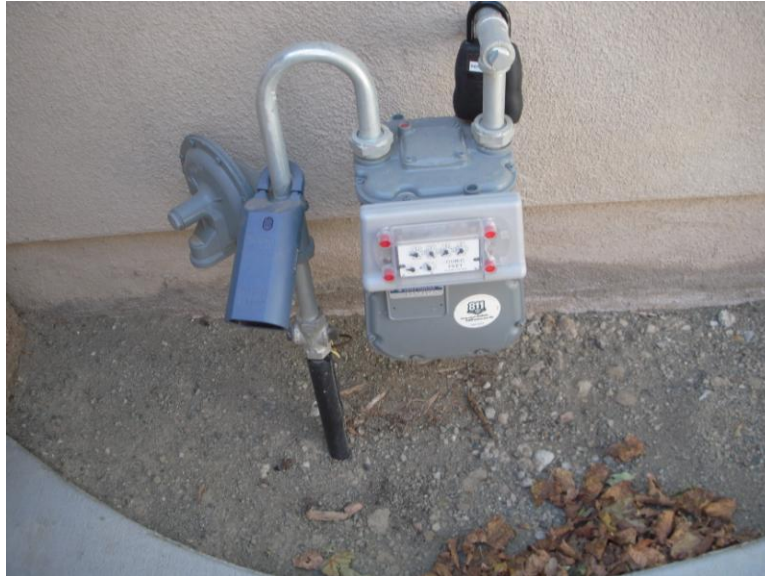
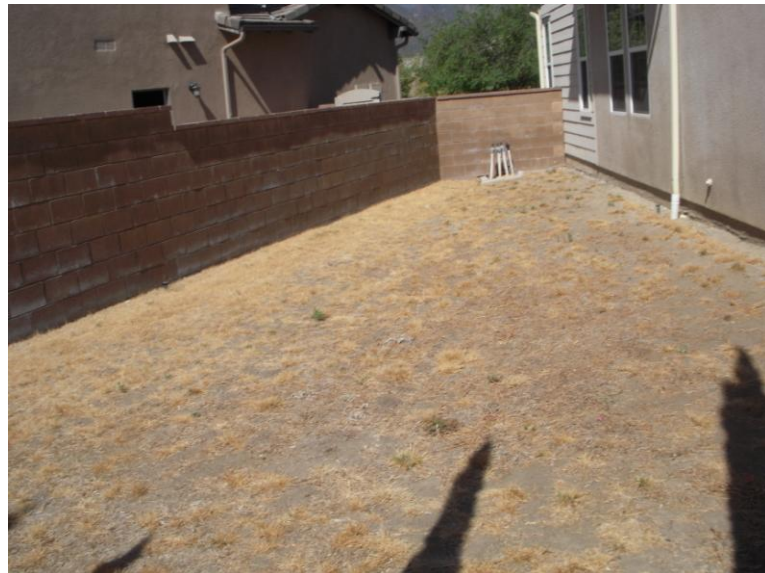
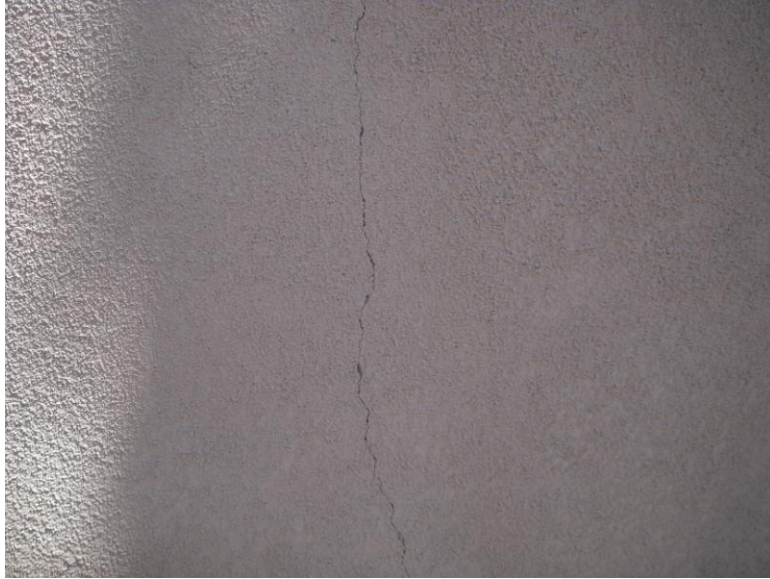
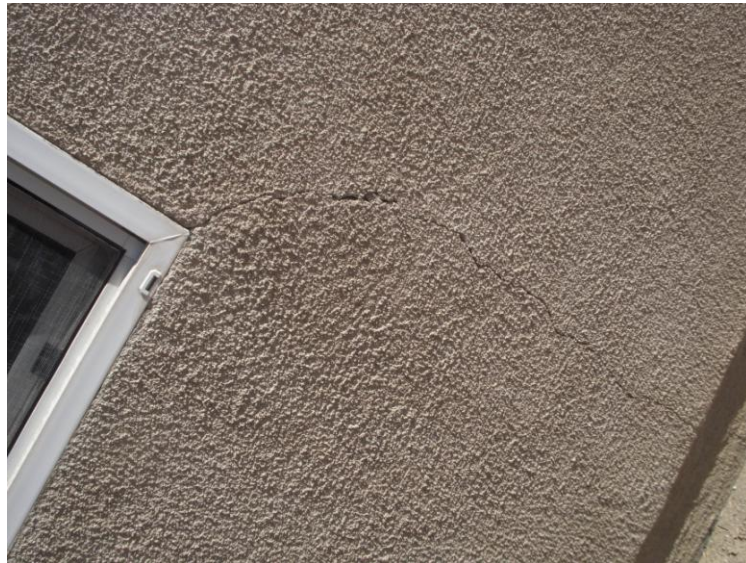
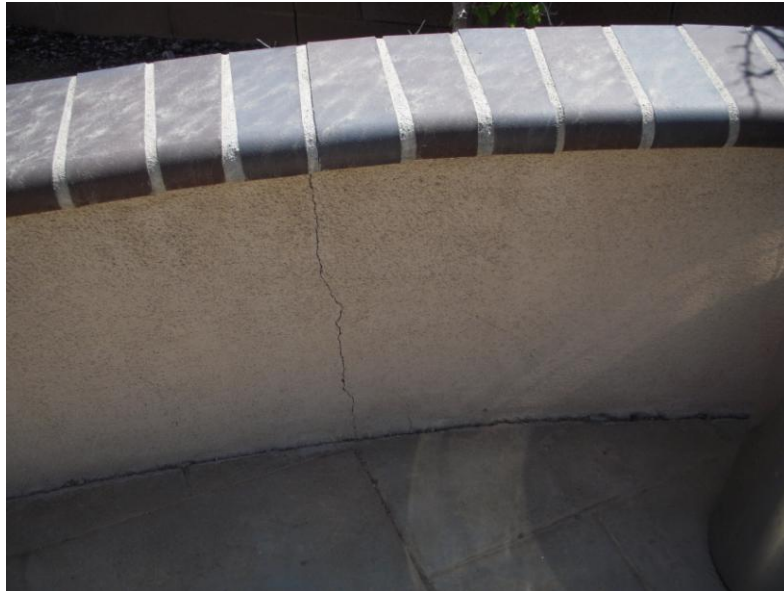
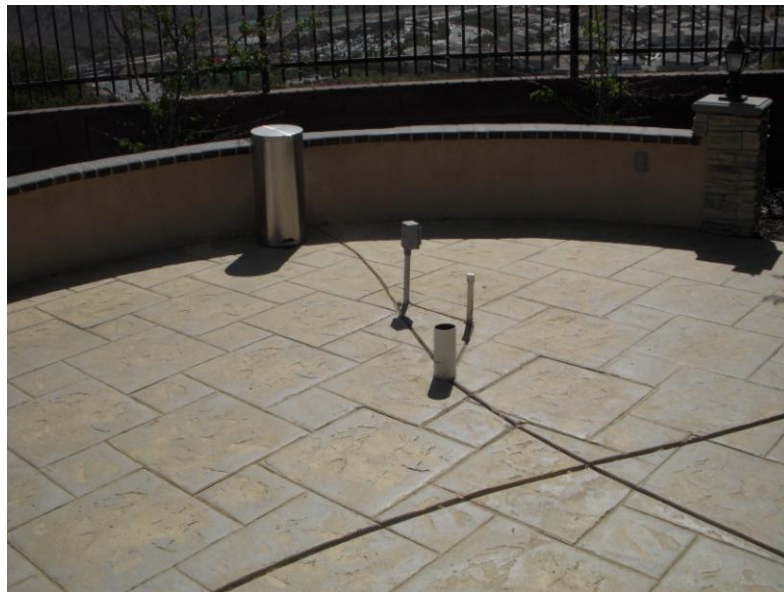
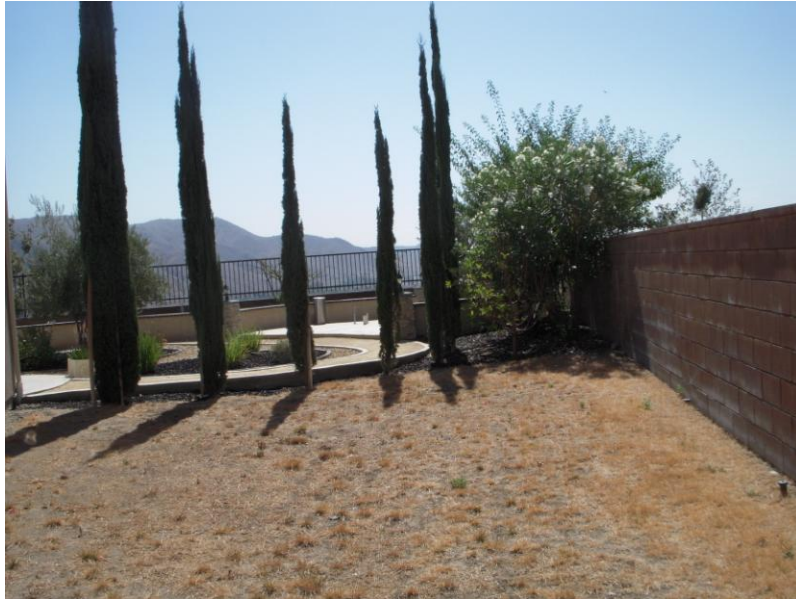
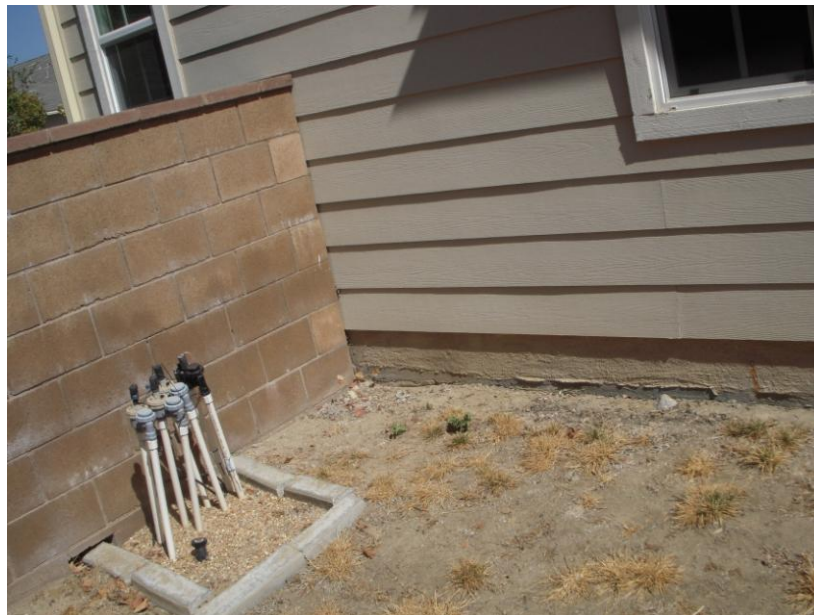
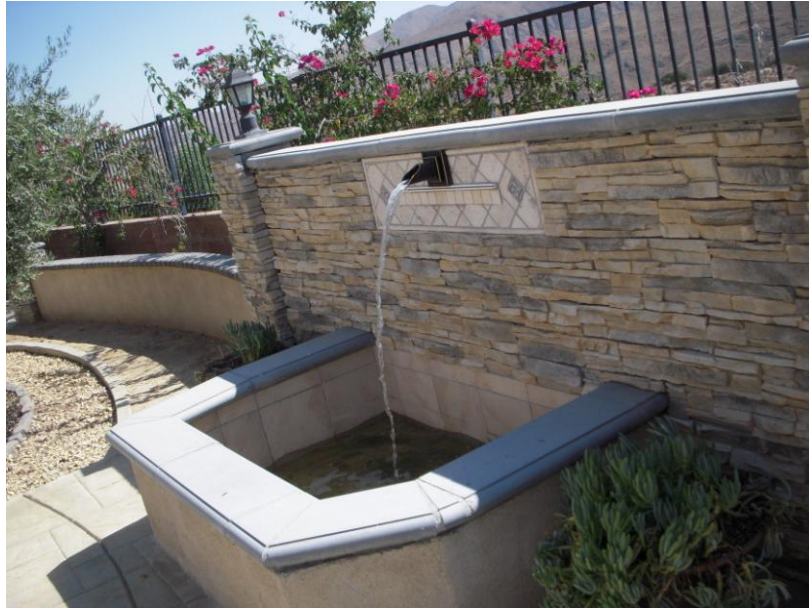
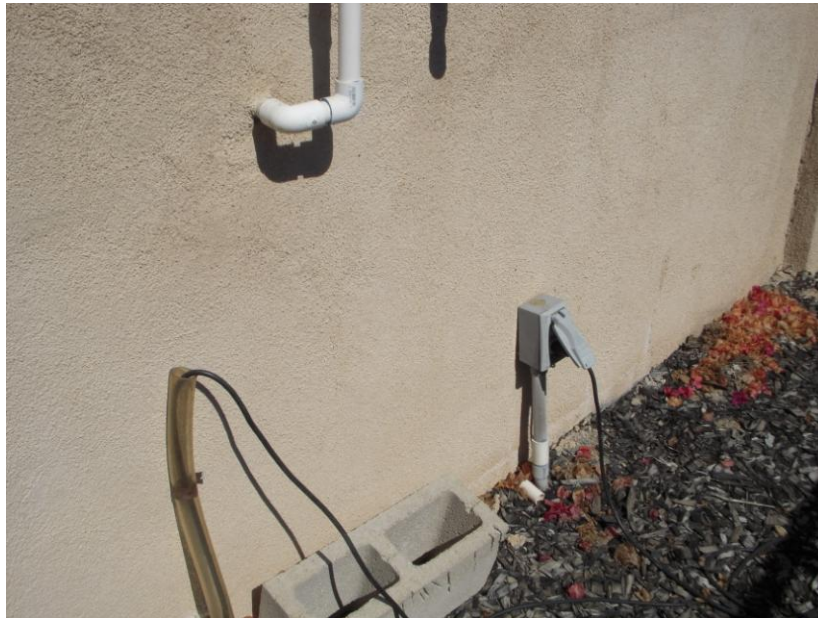
Driveway	Recommend repair few concrete cracks.
Walkway	Serviceable.
Front door	Serviceable. Recommend repair or replace the door handle.
Screen door	N/A.
Doorbell/Chime	Serviceable.
Exterior walls	There are quite few hairline cracks on the stucco walls, Recommend repair them. No structural cracks.
Fence(s)/wall(s)	Serviceable.
Gate(s)	Serviceable.
Retaining Wall	N/A.
Trim	Serviceable.
Window Frames	Serviceable.
Electrical Comments	None.
Exterior Faucets	Serviceable.
Landscape/Planters	Recommend re-grass the side area.
Sprinkler	Recommend demo the system to the buyer.
Chimney 1	Serviceable.
Lot/Grade Drainage	Serviceable.
Gas meter	Serviceable. Suggest installing seismic shut off valve, not required on this city.
Foundation	Serviceable where visible. Two-story slab on grade foundation. Recommend repair the; about foot long crack on the footing at the front by cleaning and washing the cracks then apply epoxy injection to prevent the cracks from growing. Its wood structural house typical type 5. The house construction may have plumbing, gas and electrical lines running underneath the house. Since it is impossible to determine the condition of these items by our visual inspection and they specifically excluded from the scope of this inspection.

Driveway	Recommend repair few concrete cracks.
Front door	Recommend repair or replace the door handle.
Exterior walls	There are quite few hairline cracks on the stucco walls, Recommend repair them. No structural cracks.
Landscape/Planters	Recommend re-grass the side area.
Sprinkler	Recommend demo the system to the buyer.
Gas meter	Suggest installing seismic shut off valve, not required on this city.
Foundation	Recommend repair the; about foot long crack on the footing at the front by cleaning and washing the cracks then apply epoxy injection to prevent the cracks from growing.

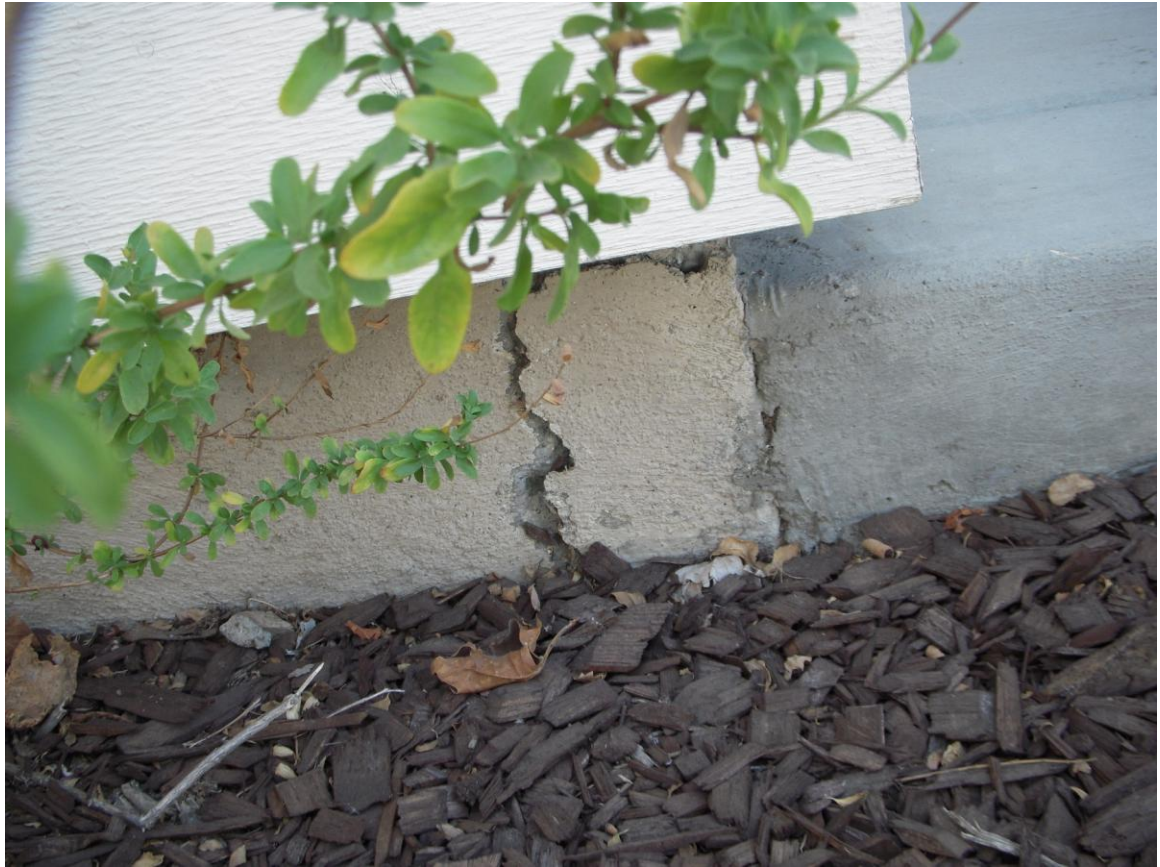
Cracks at the footing, Recommend repair it

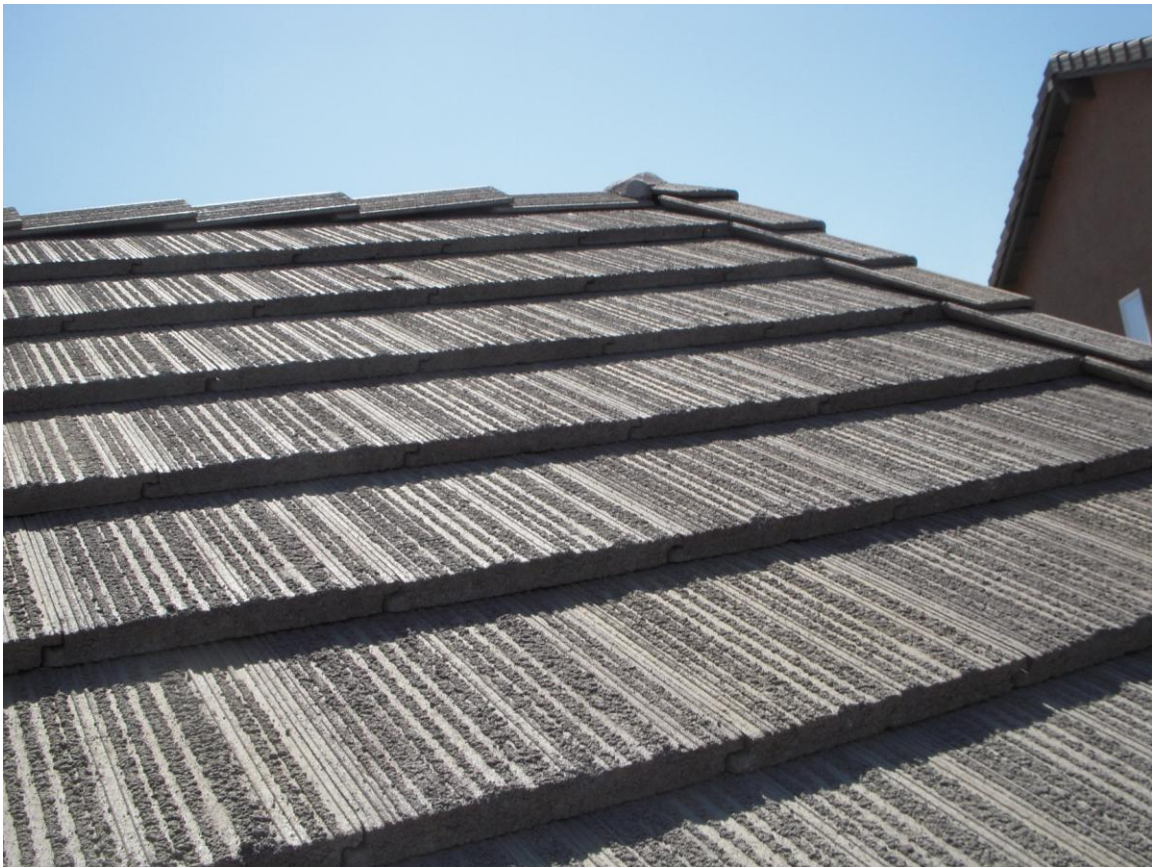
ROOF

Type/Material	Tile Roof.
Flashing	Serviceable.
Gutters/Roof Drains	Serviceable.
Roof Evaluation	Good Condition.

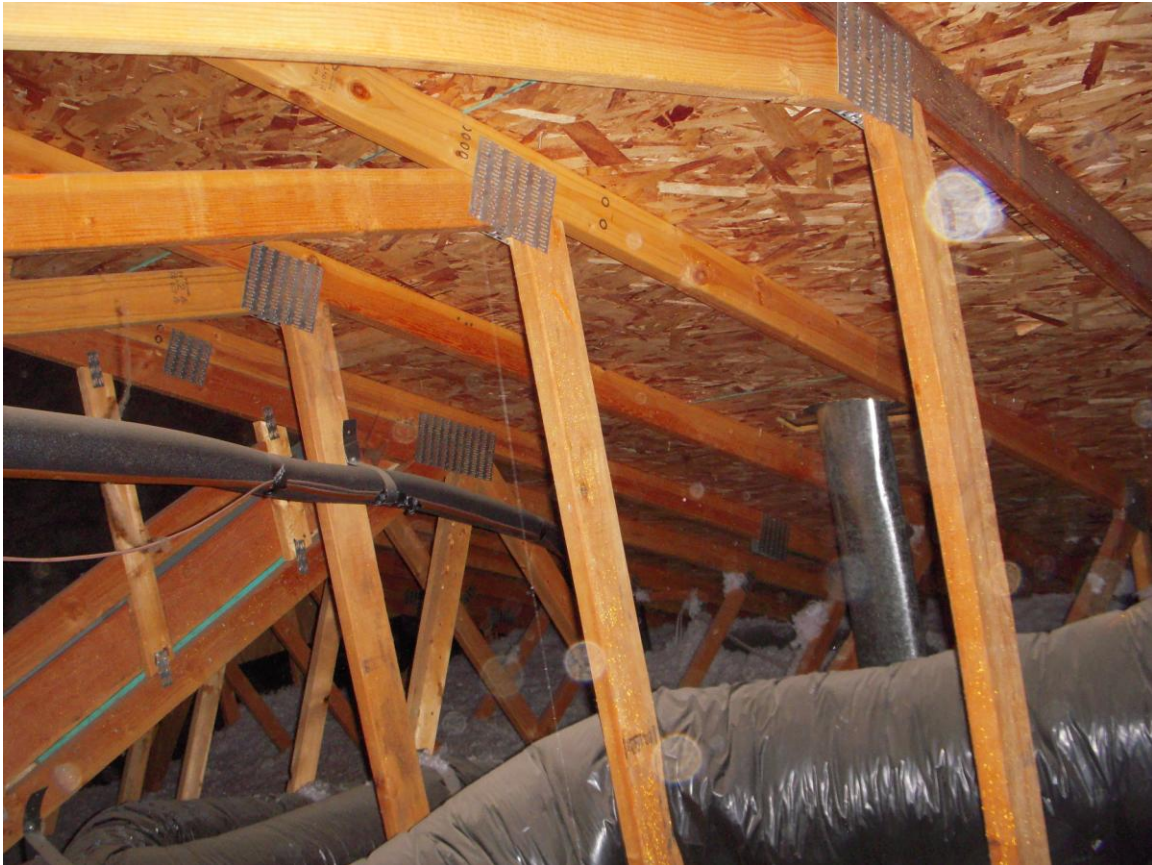
ATTIC 1

Access	Off the hallway at the 2 nd floor.
Framing	Serviceable.
Sheathing	Serviceable.
Insulation	Serviceable.
Ventilation	Serviceable.
Electrical	Serviceable.
Duct	Serviceable.

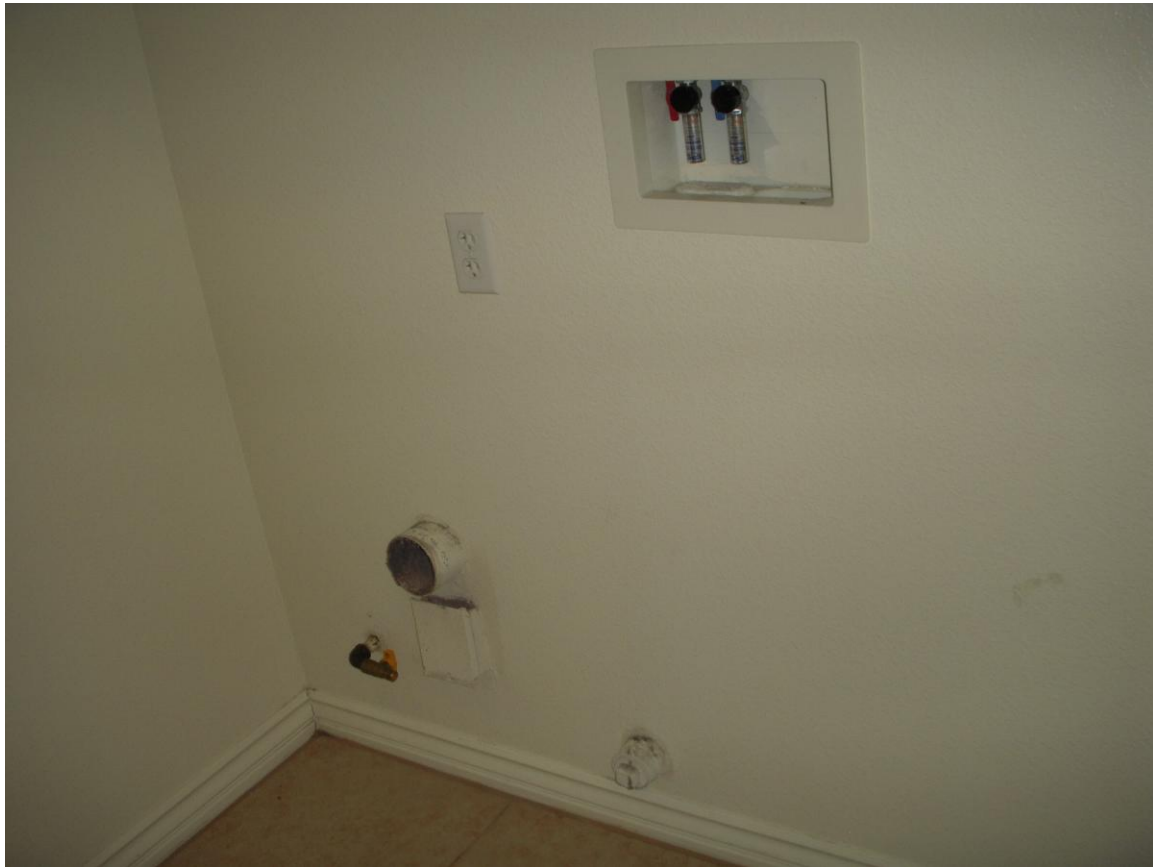
LAUNDRY ROOM

Location	Off the hallway at the 1 st floor.
Electrical	Serviceable. 110 v.
Washer hook up	Serviceable.
Dryer hook up	Serviceable. Gas hookup line was capped off.
Mechanical Fan	Serviceable.

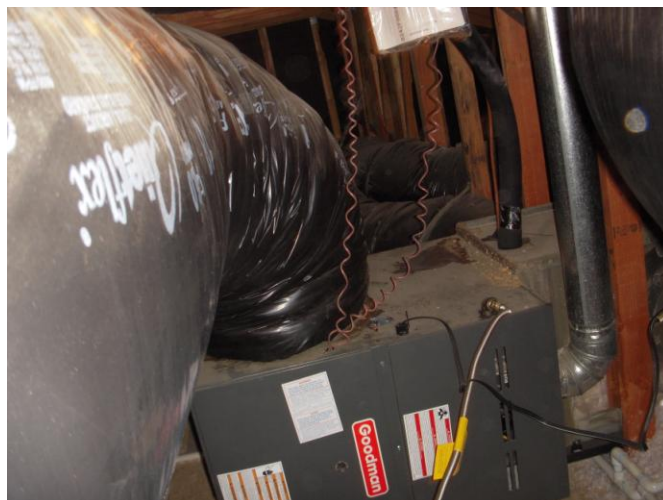
HEATING/AIR CONDITIONING

Heating	Central. Two Furnace units located in the attic.
Heater Condition	Serviceable.
Exhaust Venting	Serviceable.
Thermostat	Serviceable. Two of them; One for each floor.
Air Condition	Serviceable. Two units located outside. Recommend regular maintenance.

Air Condition	Recommend regular maintenance.
---------------	--------------------------------

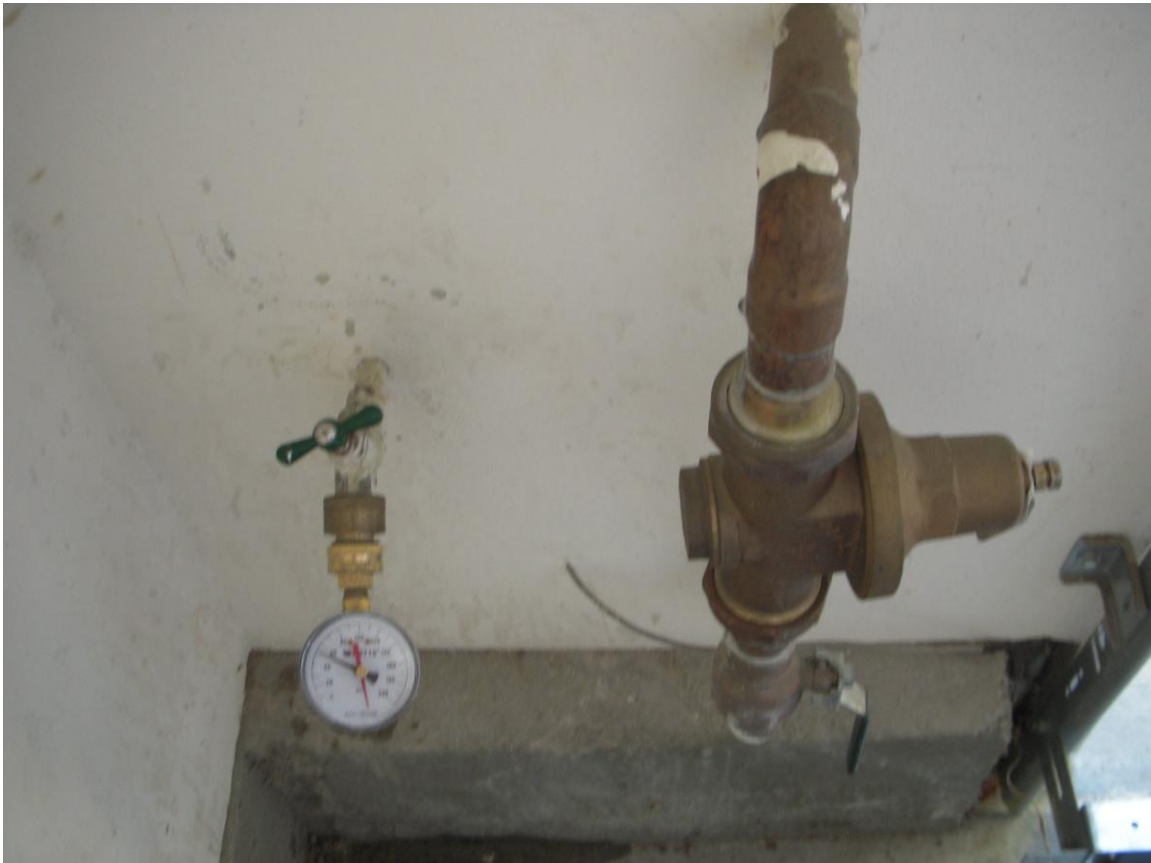
*** PLUMBING***

Plumbing Supply	Public water supply shut off location at the front curb of the house. The water pressure was 55 PSI which is not adequate; Recommend an adjustment to 60-80 PSI. There is Water Pressure Regulator located in the garage.
Supply Pipes	Serviceable. Copper and galvanize.
Plumbing Waste	Serviceable. Sewer.
Waste Pipes	Serviceable.
Water Heater	In the garage.
Water Heater Comments	There is seismic strapping; Recommend tie them down.
Exhaust Venting	Serviceable.

Plumbing Supply	The water pressure was 55 PSI which is not adequate; Recommend an adjustment to 60-80 PSI.
Water Heater Comments	There is seismic strapping, Recommend tie them down.

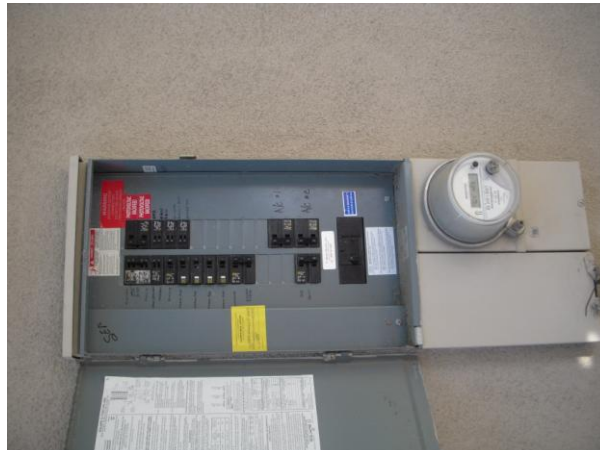
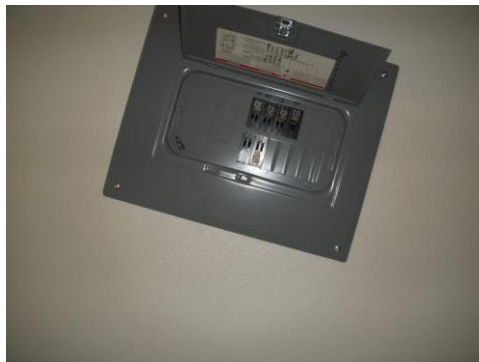
Main Box Description	Main electrical service panel located outside, overload protection provided by breakers. Electrical service is 225 amps and 120 volts. Subpanel located in the Landry room.
Main Box Wiring	Serviceable. Ground Fault Circuit Interrupters (GFCI) are available.
Smoke Detectors	Serviceable.
Carbon Monoxide detector(s)	Serviceable. Two are available, one in each floor combo.
Outlets	Serviceable.
Switches	Two were not working in the hallway going to the kitchen and the ceiling lights in that hallway were not working, Recommended repair, see the inspector mark.

Switches	Two were not working in the hallway going to the kitchen and the ceiling lights in that hallway were not working, Recommended repair, see the inspector mark.
----------	---

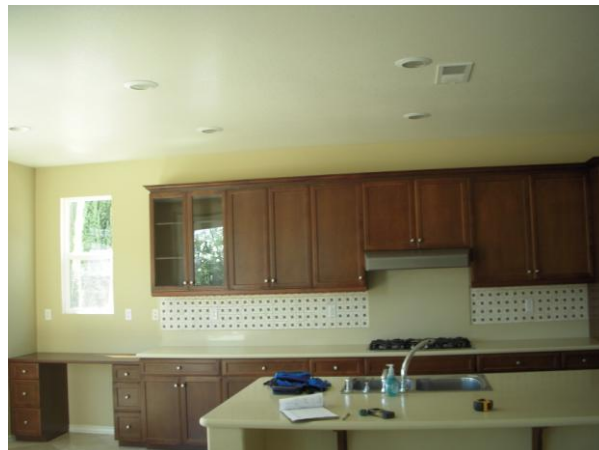
Flooring	Tiles. Recommend repair few cracks/ broken tiles.
Walls	Serviceable.
Ceiling	Serviceable.
Door	N/A.
Cabinet(s)/Closet(s)	Serviceable.
Counter tops	Serviceable.
Electrical	Serviceable.
Sink(s)	Serviceable.
Faucets	Serviceable.
Traps/Drains	Serviceable.
Disposal	Serviceable.
Dishwasher	Serviceable.
Garbage compactor	N/A.
Stove/Cook top	Serviceable. Gas stove and Electrical oven.
Range Hood Vent	Serviceable.
Window/Screen	Serviceable for the breakfast area.
Breakfast Area	Serviceable.

Flooring	Tiles. Recommend repair few cracks/ broken tiles.
----------	---

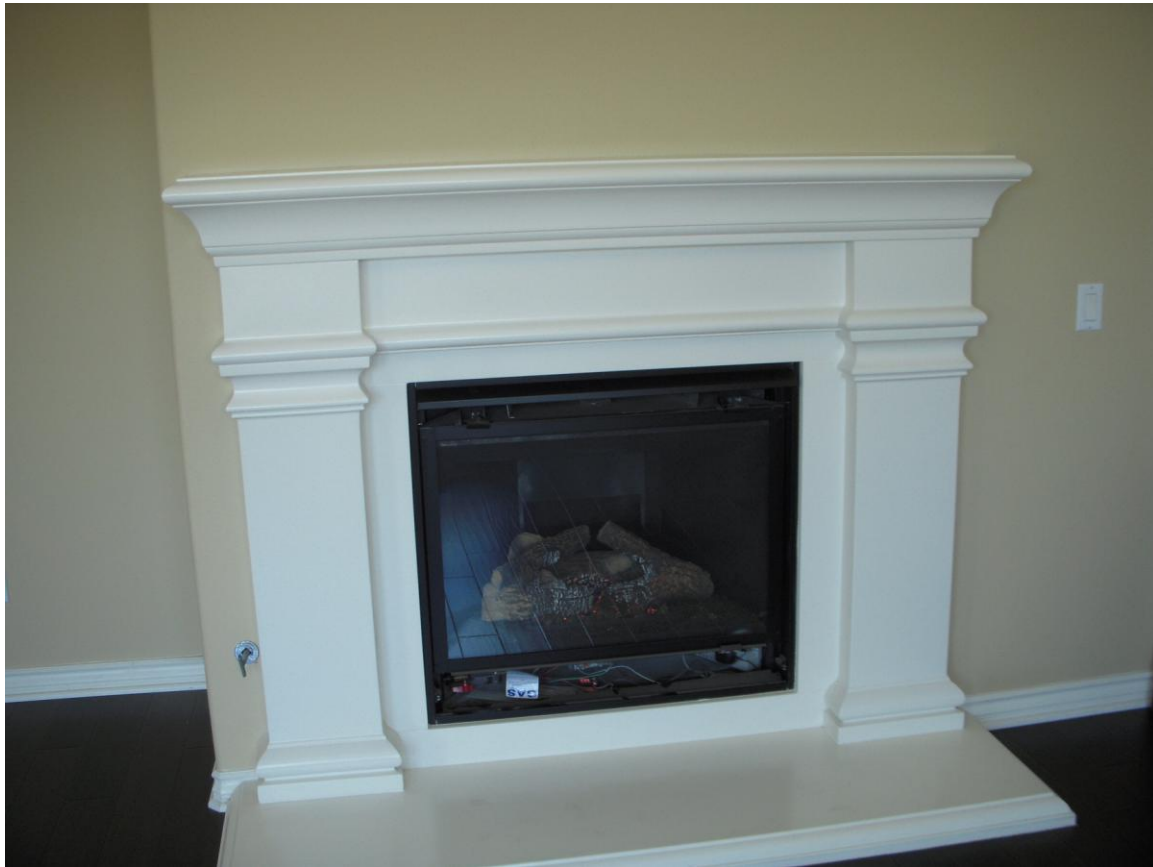
FIREPLACE

Location	Off the Family room.
Condition	Good. Electronic igniter with a switch.

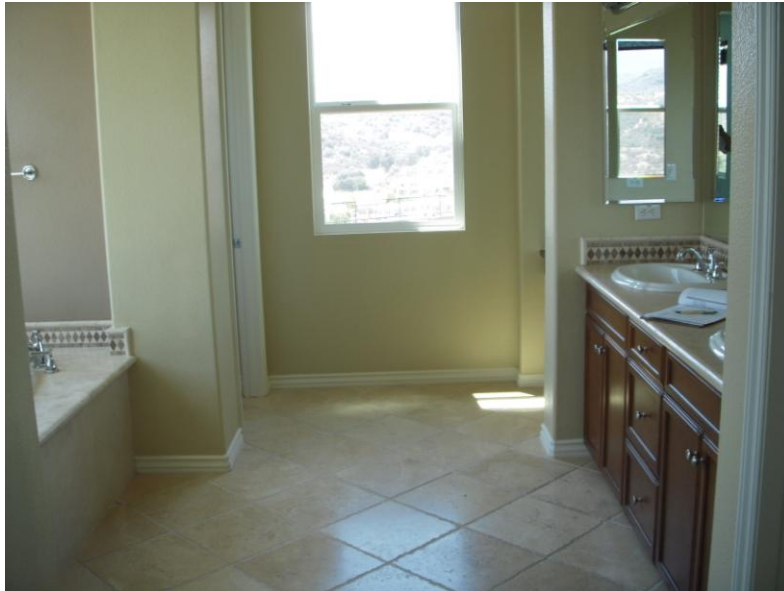
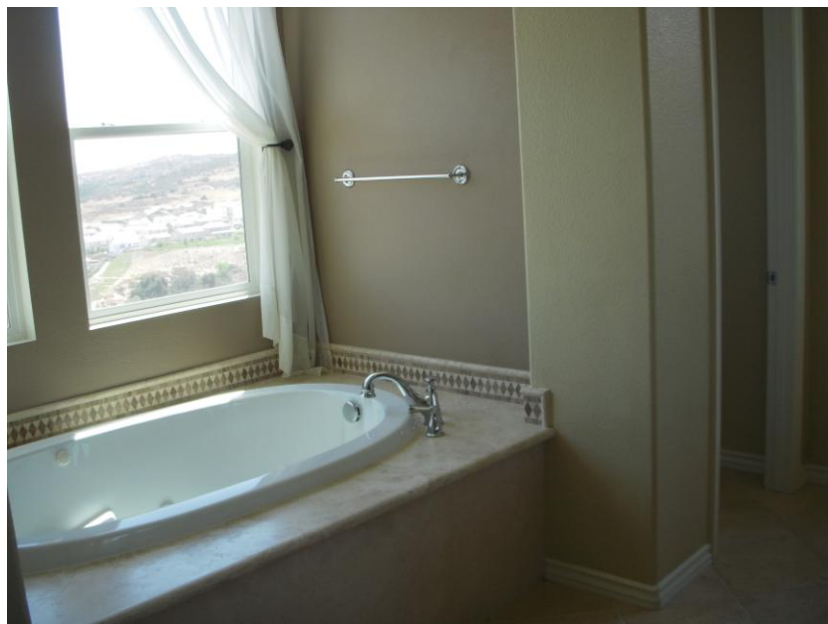
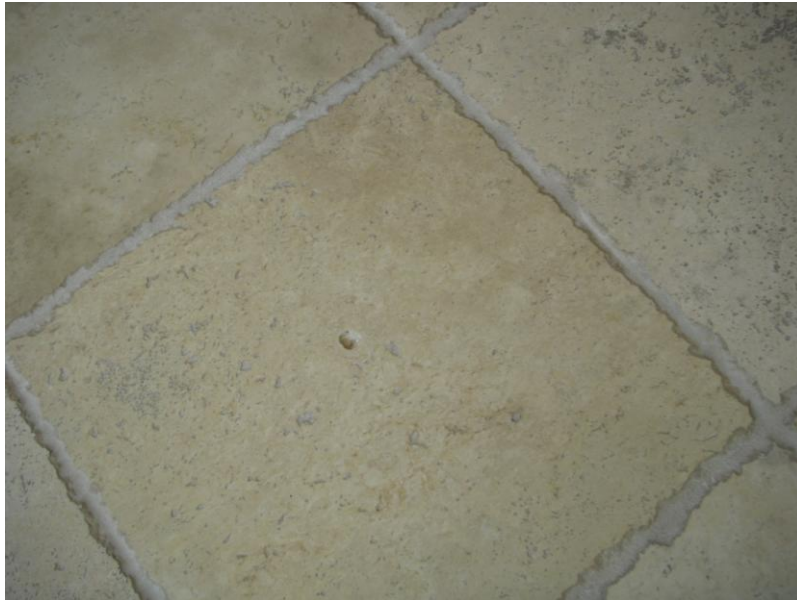
Location	In the master bedroom.
Flooring	Recommend repair few broken/cracks tiles.
Walls	Serviceable.
Ceiling	Serviceable.
Door	Serviceable.
Electrical	Serviceable.
Window(s)	Serviceable.
Shower/faucet	Serviceable.
Shower drains	Serviceable.
Sink 1 & 2	Serviceable.
Sink Faucet(s)	Serviceable.
Sink Drain(s)	Serviceable.
Toilet	Serviceable.
Counter(s)/Cabinet(s)	Serviceable.
Heating	Serviceable.
Air Condition	Serviceable.
Exhaust Fan	Serviceable.
Bathtub	Serviceable.
Tub Faucet/Jet	Serviceable. The jet tub was inspected and it was working condition. The exterior wall behind the jet tub has excess to the jet motor in case of repair or maintenance.

Flooring	Recommend repair few broken/cracks tiles.
----------	---

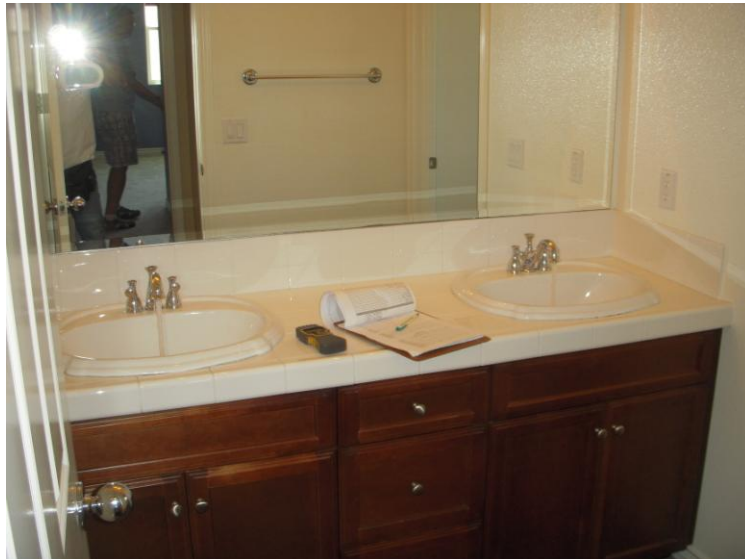
BATHROOM 2

Location	Off the hallway at the 2 nd floor.
Flooring	Serviceable. Tile.
Walls	Serviceable.
Ceiling	Serviceable.
Door	Serviceable.
Electrical	Serviceable.
Window(s)	Serviceable.
Shower/Tub faucet	Serviceable.
Shower/faucet	Serviceable.
Shower drains	Serviceable.
Sink 1 & 2	Serviceable.
Sink Faucet(s)	Serviceable.
Sink Drain(s)	Serviceable.
Toilet	Serviceable.
Counter(s)/Cabinet(s)	Serviceable.
Heating	Serviceable.
Air Condition	Serviceable.
Exhaust Fan	Serviceable.

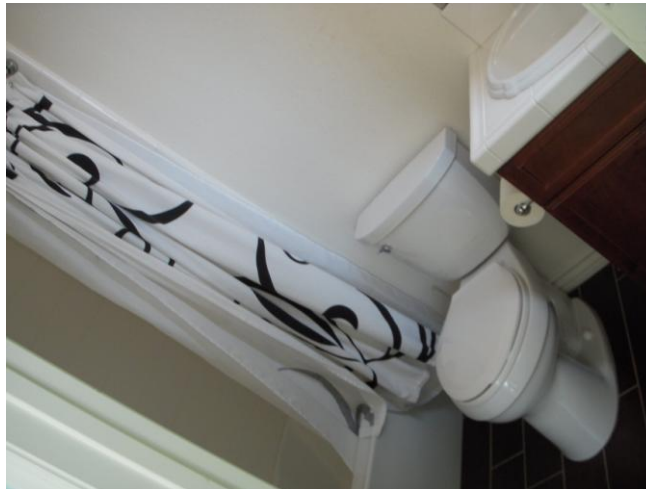
BATHROOM 3

Location	Off bedroom # 4 at the 1 st floor.
Flooring	Serviceable. Tile.
Walls	Serviceable. Recommend replace out of order light bulb above the sink.
Ceiling	Serviceable.
Door	Serviceable.
Electrical	Serviceable.
Window(s)	Serviceable.
Shower/Tub faucet	Serviceable.
Shower/faucet	Serviceable.
Shower drains	Serviceable.
Sink	Serviceable.
Sink Faucet(s)	Serviceable.
Sink Drain(s)	Serviceable.
Toilet	Serviceable.
Counter(s)/Cabinet(s)	Serviceable.
Heating	Serviceable.
Air Condition	Serviceable.
Exhaust Fan	Serviceable.

Walls	Recommend replace out of order light bulb above the sink.
-------	---

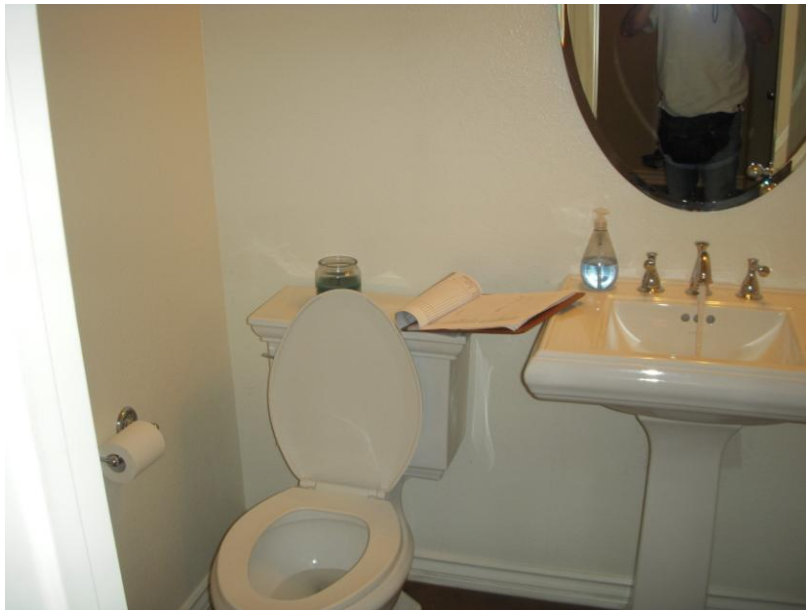
1/2 BATHROOM 4 No Shower

Location	At the 1 st floor.
Flooring	Serviceable. Tile.
Walls	Serviceable.
Ceiling	Serviceable.
Door	Serviceable.
Electrical	Serviceable.
Window(s)	N/A.
Sink	Serviceable.
Sink Faucet(s)	Serviceable.
Sink Drain(s)	Serviceable.
Toilet	Serviceable.
Heating	Serviceable.
Air Condition	Serviceable.
Exhaust Fan	Serviceable.
