Inspection No: 999-062813-1

Inspection Date: June 28, 2013 @ 11:50 PM Friday

Inspection Address: MLS# SR13114838

Description	One story, Single Family Residence consists of 3 bedrooms and 2 Bathrooms. Attached 2 car garages. The living area of the house is 1349 square feet and the lot size is 7628 square feet.
Age	The house was built in 1956.
Weather	The weather was sunny (85-90 F)
Occupancy	The house occupied at the time of inspection.

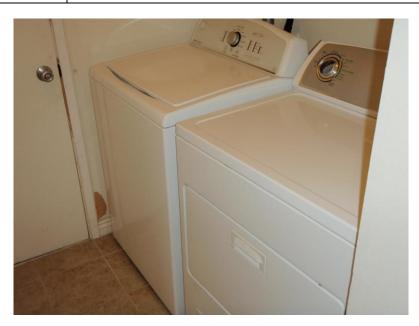
LAUNDRY ROOM

Location	In the hallway leading to the garage
Electrical	Serviceable. 110 v.
Washer hook up	Serviceable.
Dryer hook up	Serviceable 110V plus Gas hookup.
Mechanical Fan	Serviceable
Wall	Serviceable

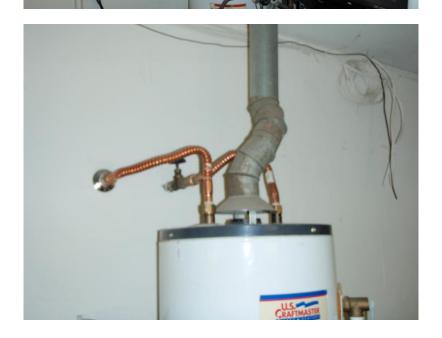
HERCULUS (S)

Plumbing Supply	Public water supply, shut off location is at the front. The water pressure was 100 PSI which is not adequate . Recommend an adjustment to (60-80) PSI.
Supply Pipes	Serviceable. Galvanized and Copper.
Plumbing Waste	Serviceable.
Waste Pipes	Serviceable.
Water Heater	Serviceable. In the garage.
Water Heater Comments	Serviceable
Exhaust Venting	Serviceable.

Plumbing Supply	Public water supply, shut off location is at the front. The water pressure was	
	100 PSI which is adequate. Recommend an adjustment to (60-80) PSI.

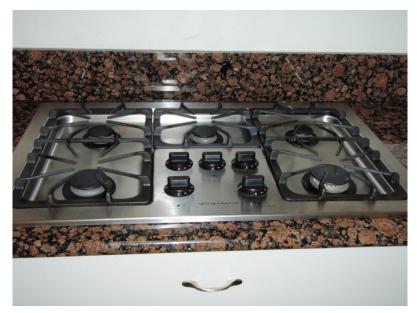
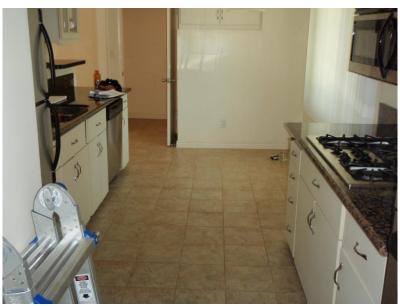
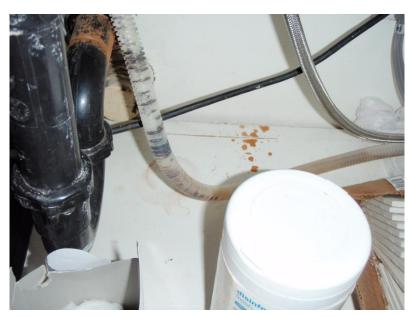
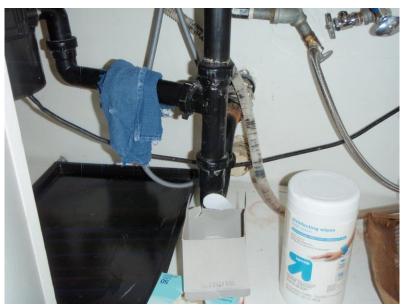
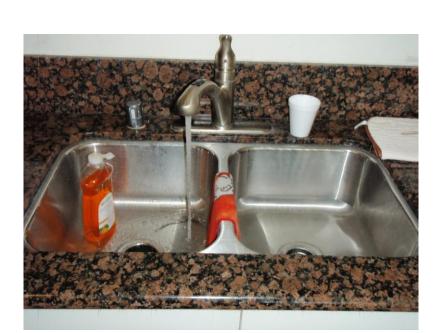
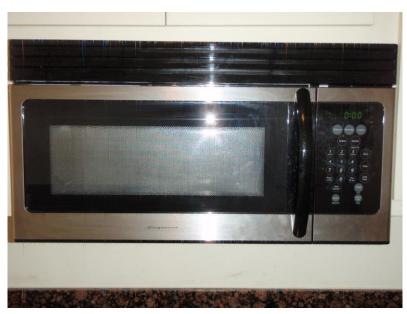
Flooring	Serviceable. Tile
Walls	Serviceable. Recommend painting
Ceiling	Serviceable.
Door	Serviceable
Cabinet(s)/Closet(s)	Serviceable
Counter tops	Serviceable. Granit
Electrical	Serviceable.
Sink(s)	Serviceable.
Faucets	Serviceable.
Traps/Drains	Serviceable
Disposal	Serviceable.
Dishwasher	Serviceable.
Garbage compactor	N/A.
Stove/Cook top	Serviceable. Gas.
Range Hood Vent	Serviceable.
Window	N/A.

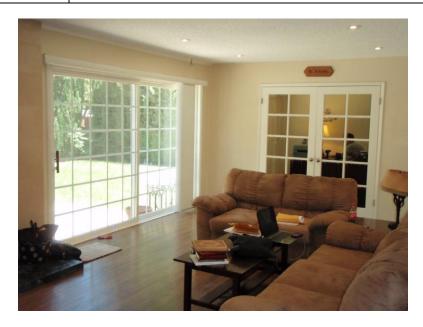
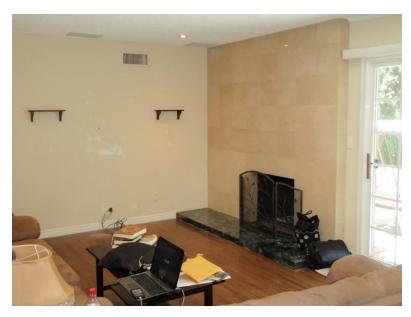
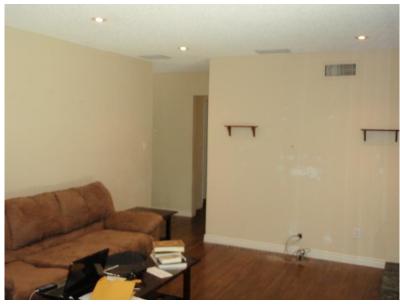
FAMILY/LIVING ROOM

Location	Behind the kitchen
	Definite the Kitchen
Flooring	Serviceable. wood
Walls	Serviceable. Recommend patching and painting
Ceiling	Serviceable.
Sliding Glass door	Serviceable.
Sliding Screen Door	Serviceable
Electrical	Serviceable

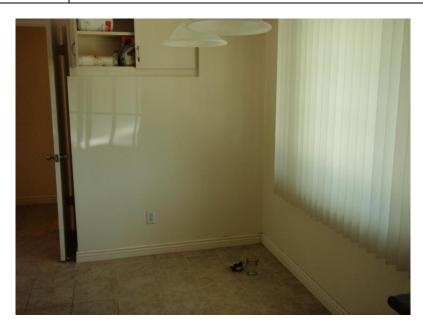
DINING ROOM

Location	In the kitchen.
Flooring	Serviceable. Tile
Walls	Serviceable.
Ceiling	Serviceable.
Window(s)	Serviceable.
Window Screen(s)	Serviceable.
Electrical	Serviceable.

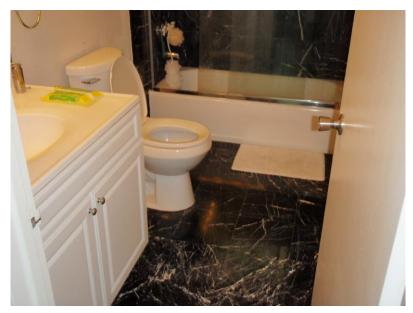
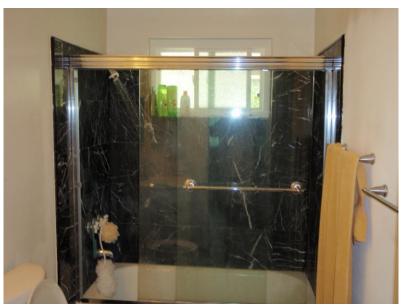
MASTER BATHROOM 1

Location	Across From the master Bedroom
Flooring	Serviceable. Tile
Walls	Serviceable. Recommend painting
Ceiling	Serviceable.
Door 1	Serviceable.
Electrical	Serviceable
Window(s)	Serviceable.
Window Screen(s)	Serviceable
Shower/Tub faucet	Serviceable.
Shower/Enclosure	Serviceable.
Shower drains	Serviceable.
Sink 1	Serviceable.
Sink Faucet(s)	Serviceable.
Sink Drain(s)	Serviceable
Toilet	Serviceable.
Counter(s)/Cabinet(s)	Serviceable.
Heating	N/A
Air Condition	N/A
Exhaust Fan	N/A.

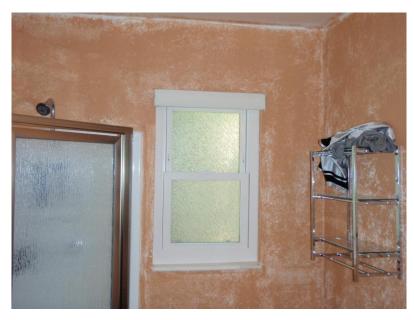
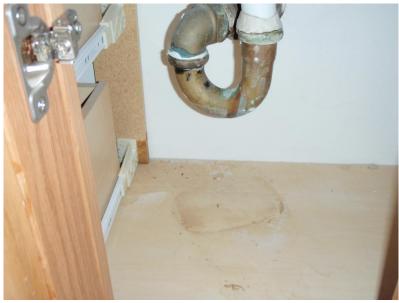
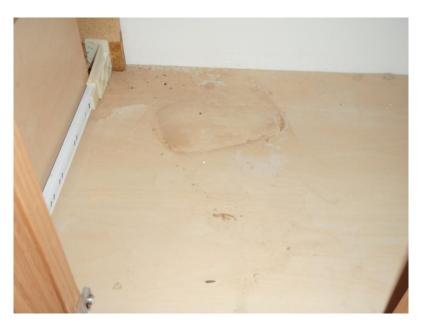
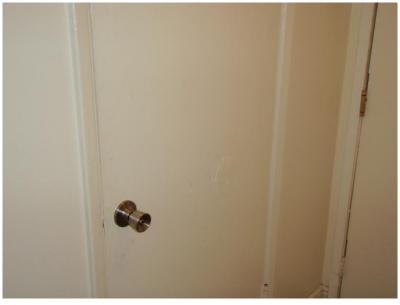
Location	Off the hallway by the Garage
Flooring	Serviceable. Tile
Walls	Serviceable. Recommend painting
Ceiling	Serviceable.
Door 1	Recommend replacing the door. Patched hole from the outside
Electrical	Serviceable.
Window(s)	Serviceable
Shower faucet	Serviceable
Shower/Enclosure	Serviceable
Shower drains	Serviceable
Sink	Serviceable.
Sink Faucet(s)	Serviceable.
Sink Drain(s)	Recommend repairing the leak
Toilet	Serviceable.
Counter(s)/Cabinet(s)	Serviceable.
Heating	N/A
Air Condition	N/A
Exhaust Fan	Serviceable.

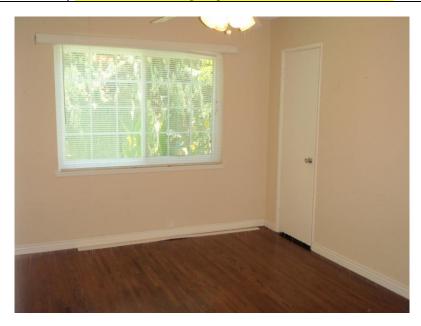
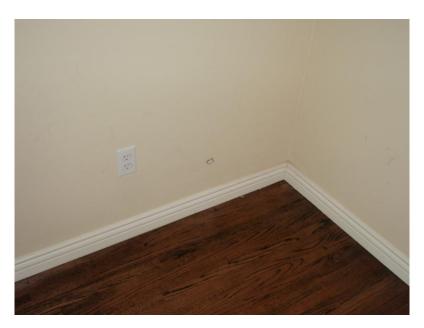
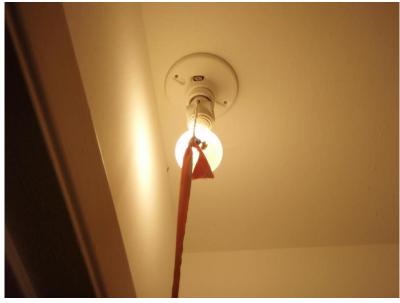
MASTER BEDROOM 1

Location	1 st room of the hallway next to living room
Flooring	Serviceable. wood
Walls	Serviceable. Recommend Patching and painting
Ceiling	Serviceable.
Door 1	Serviceable
Window(s)	Serviceable
Electrical	Serviceable
Closet(s)	Recommend installing a light fixture cover inside the closet

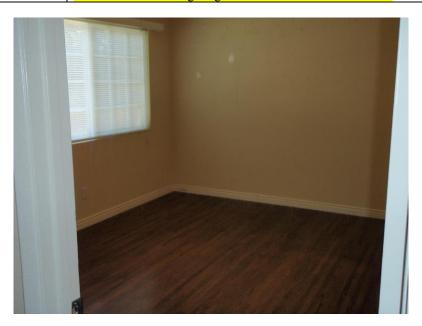
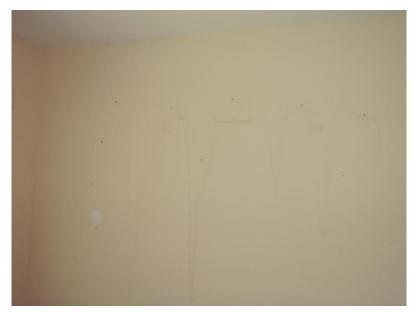
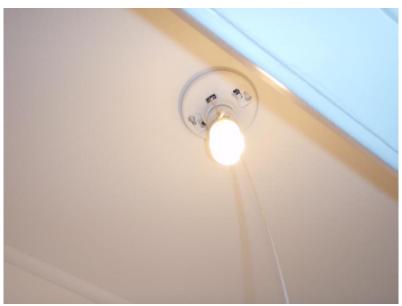
BEDROOM 2

Location	2 nd room of the hallway next to master bedroom
Flooring	Serviceable. wood
Walls	Serviceable. Recommend Patching and painting
Ceiling	Serviceable.
Door 1	Serviceable
Window(s)	Serviceable
Electrical	Serviceable
Closet(s)	Recommend installing a light fixture cover inside the closet

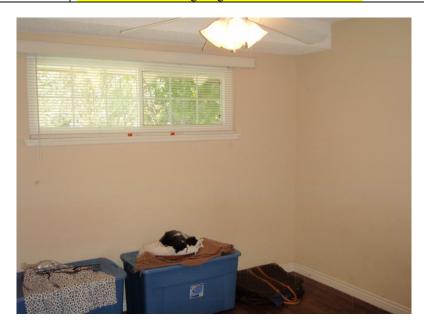
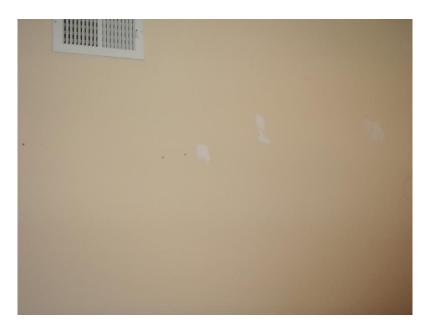
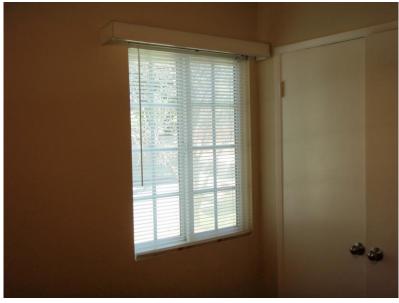
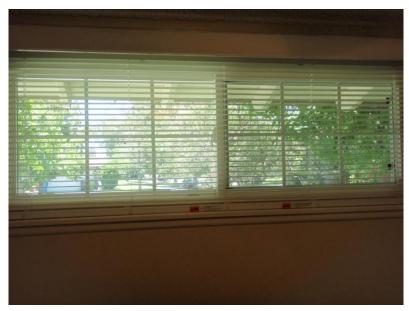
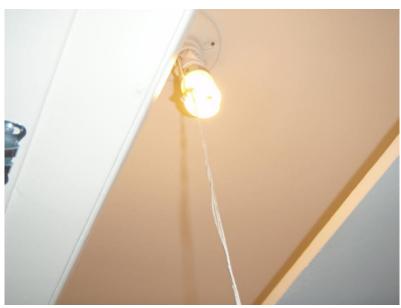
BEDROOM 3

Location	Across from bedroom 2
Flooring	Serviceable. wood
Walls	Serviceable. Recommend Patching and painting
Ceiling	Serviceable.
Door 1	Serviceable
Window(s)	Serviceable
Electrical	Serviceable
Closet(s)	Recommend installing a light fixture inside the closet

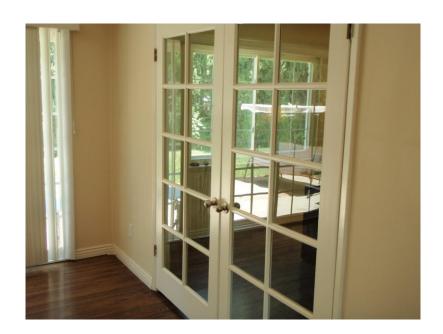
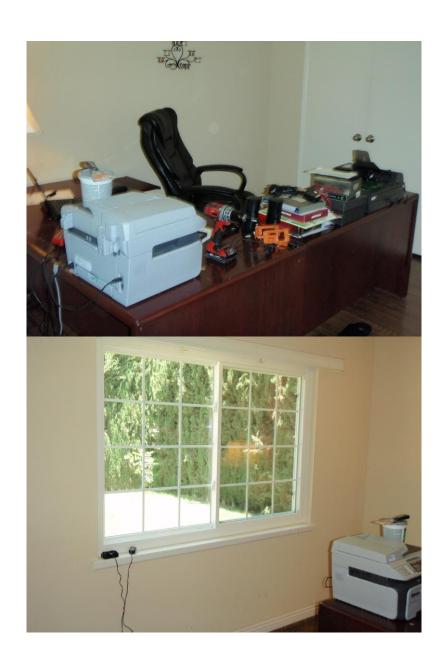
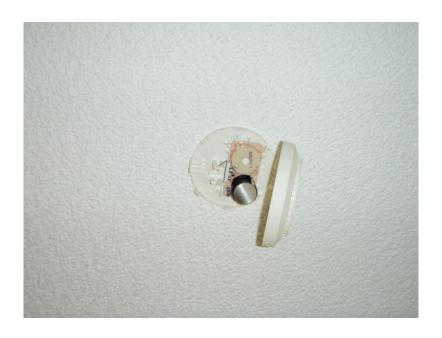
LOFT/OFFICE

Location	Next to living room
Flooring	Serviceable. wood
Walls	Serviceable. Recommend Painting
Ceiling	Serviceable.
Door 1	Serviceable
Window(s)	Serviceable
Electrical	Serviceable
Closet(s)	Serviceable
